MERCURY INVESTIGATION REPORT

**Hunterdon Central Regional High School
Auxiliary Gym
84 Route 31
Flemington, New Jersey 08822**

PARS Environmental, Inc.
500 Horizon Drive, Suite 540
Robbinsville, NJ 08691

August 2019

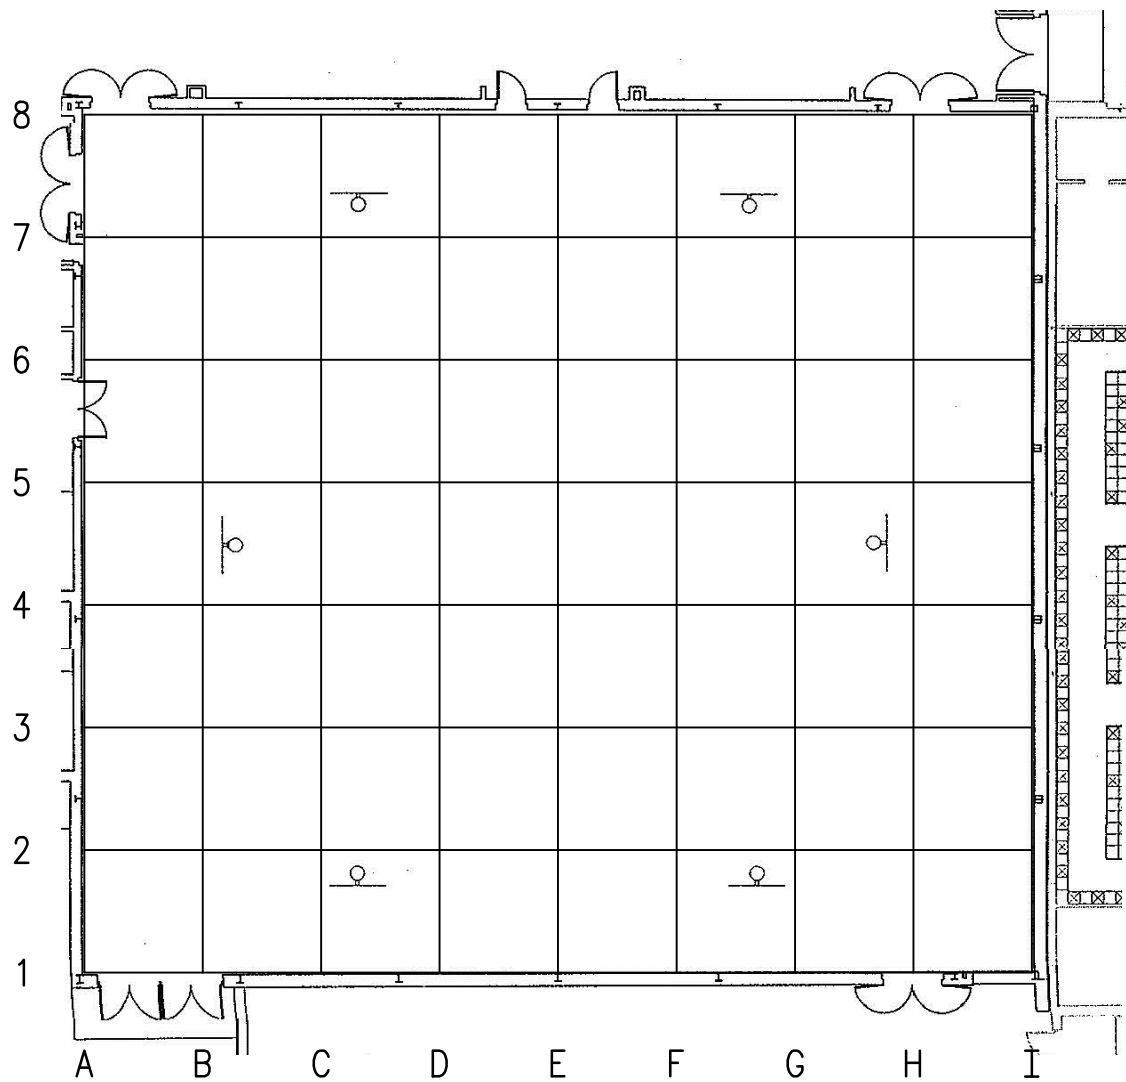
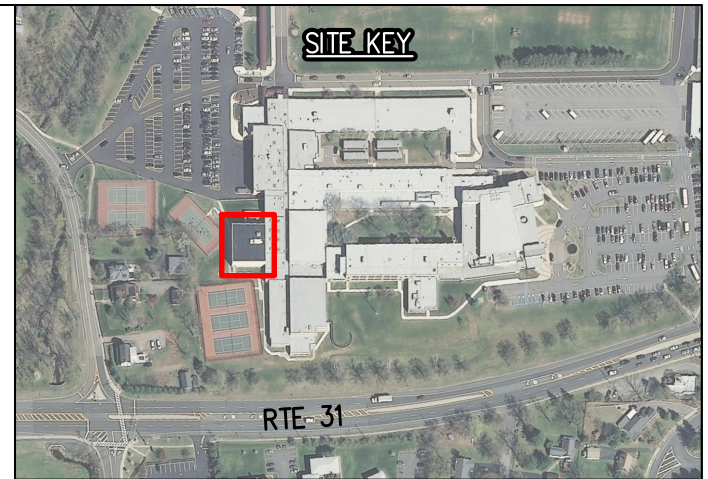
**FIGURE 1
Jerome Sample Location Map**

PARS utilized a Jerome J505 Mercury Vapor Analyzer to collect real-time mercury vapor concentrations within the auxiliary gymnasium. Vapor screening was conducted using a pre-determined grid pattern, with samples collected approximately every ten feet, starting at and including the edges of the space. The grid used to determine approximate sample locations is provided in **Figure 1**.

Some readings slightly deviated from the pre-determined grid, biased to areas likely to give off mercury vapors, i.e. areas where the floor was cracked or damaged, or where penetrations and holes or seams were observed. Readings were also obtained outside the auxiliary gymnasium for comparison.
